Technical Report

PROTECTION OF MOORING BUOYS
PART VII. RESULTS OF SIXTH
RATING INSPECTION

December 1965

U. S. NAVAL CIVIL ENGINEERING LABORATORY
Port Hueneme, California

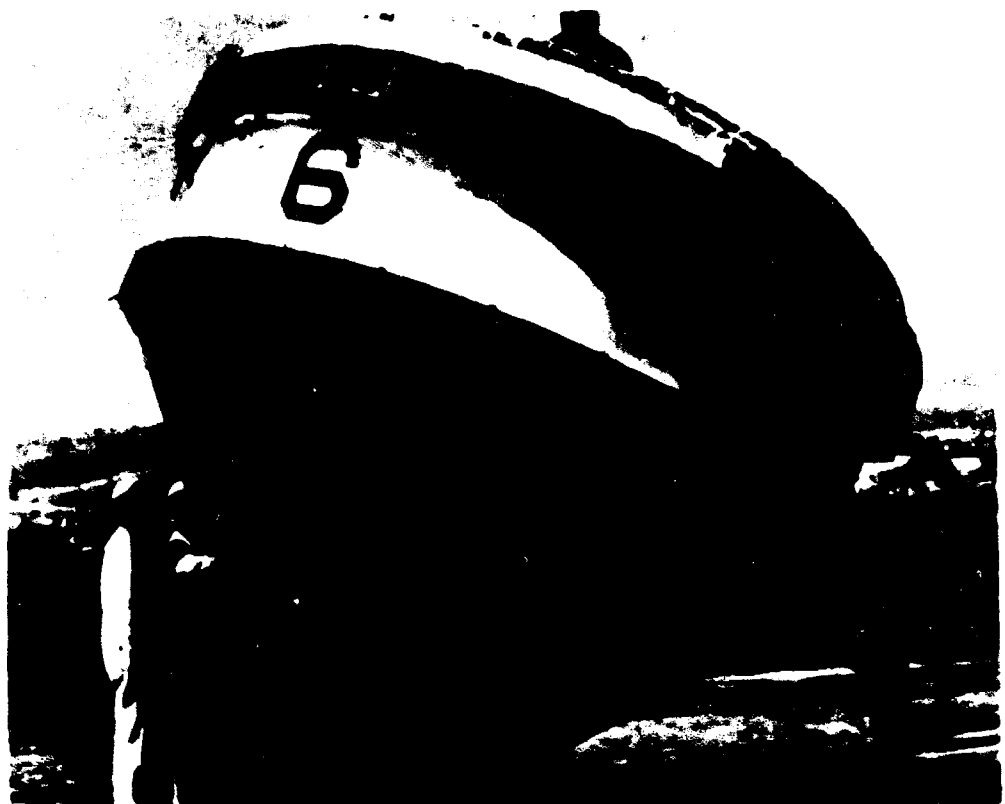
The condition of the System 4 buoy (Figure 6) was essentially unchanged since the previous inspection. The previously reported delamination of the topcoat and seal coat in the submerged zone had not advanced significantly, and the underlying epoxy primer and coal tar epoxy were providing good protection to the steel. Elsewhere, the entire coating system was performing well.

Figure 6. Inspection of System 4 buoy after removal of fouling.

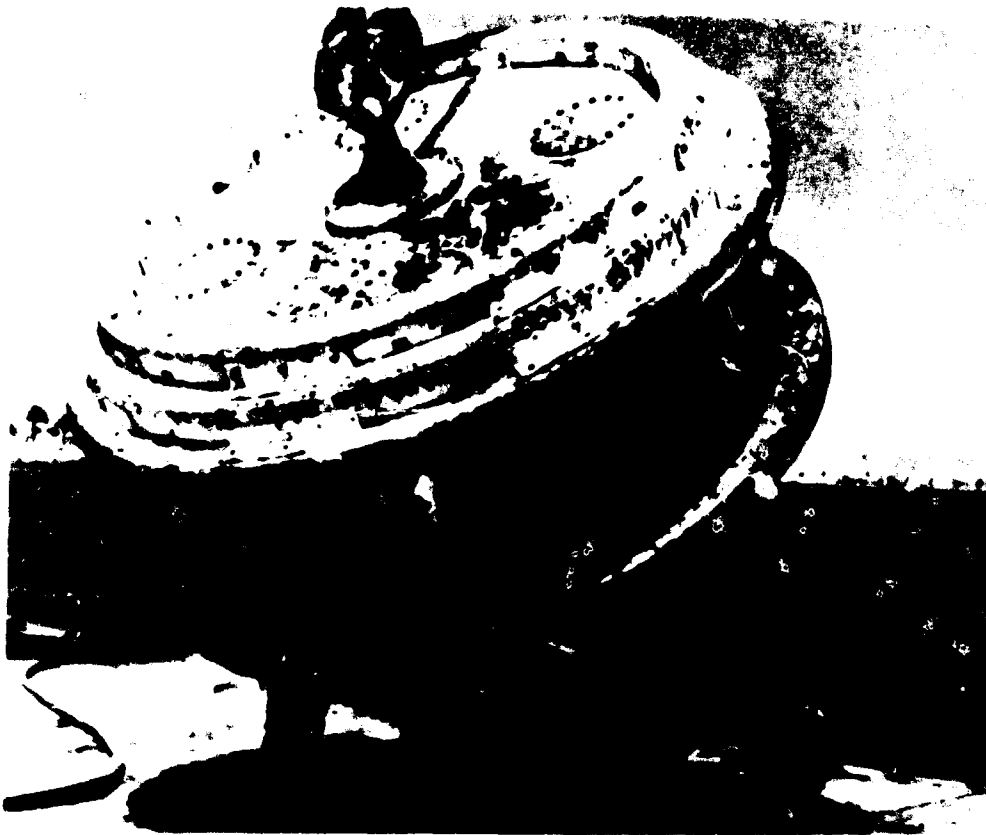
The condition of the System 5 buoy (Figure 7) was essentially unchanged since the previous inspection. This buoy had suffered extensive abrasion damage in the submerged zone during its first 6 months exposure, but this area has since undergone relatively little further deterioration. The greatly reduced amount of galvanic corrosion previously noted on rivet heads in this area may have occurred after the work-hardened exterior of these heads had been lost. Most of the damage in the atmospheric and splash zones were related to abrasion, especially the top where extensive abrasion by the securing assembly had occurred.

Figure 7. System 5 buoy after removal of fouling.

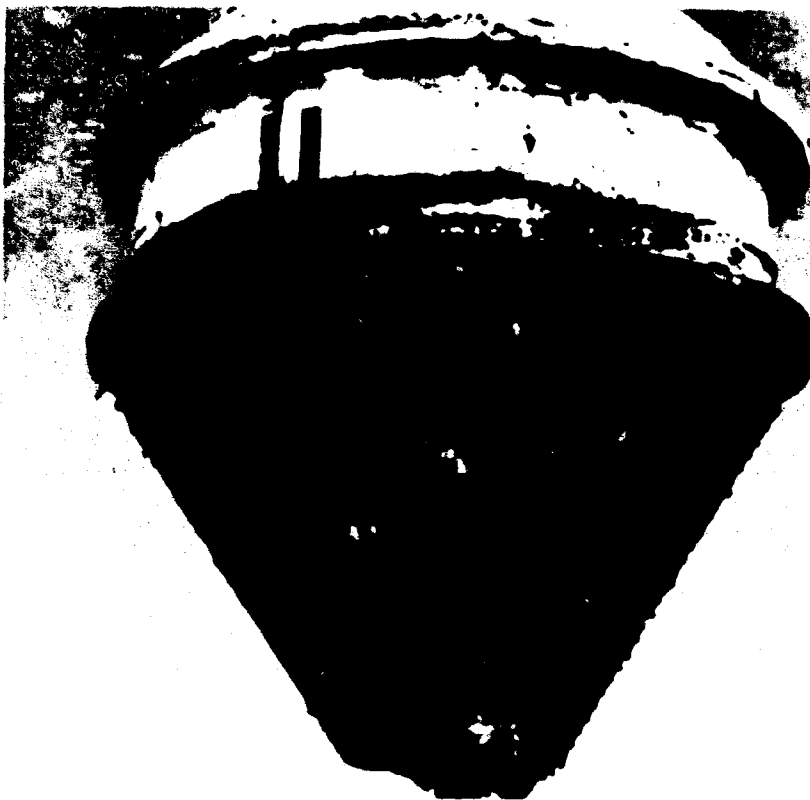
Systems 6 and 6C were identical, but the 6C coating was applied to a cathodically protected buoy. The condition of both buoys (Figure 8) was essentially unchanged since the last inspection. Most of the damage to both buoys was related

to abrasion by ships and mooring lines. The better condition of the System 6C buoy was related to (1) the heavier fendering system of the Mark II as compared to the Mark I buoy, (2) the greater resultant freeboard, and (3) the cathodic protection provided. The rust on the submerged portion of the cathodically protected buoy was light, loosely held, and free of pitting. Some of the rusting near the top of this zone may have occurred while the buoy was tilted by a moored vessel.

Figure 8. System 6 buoy after removal of fouling.

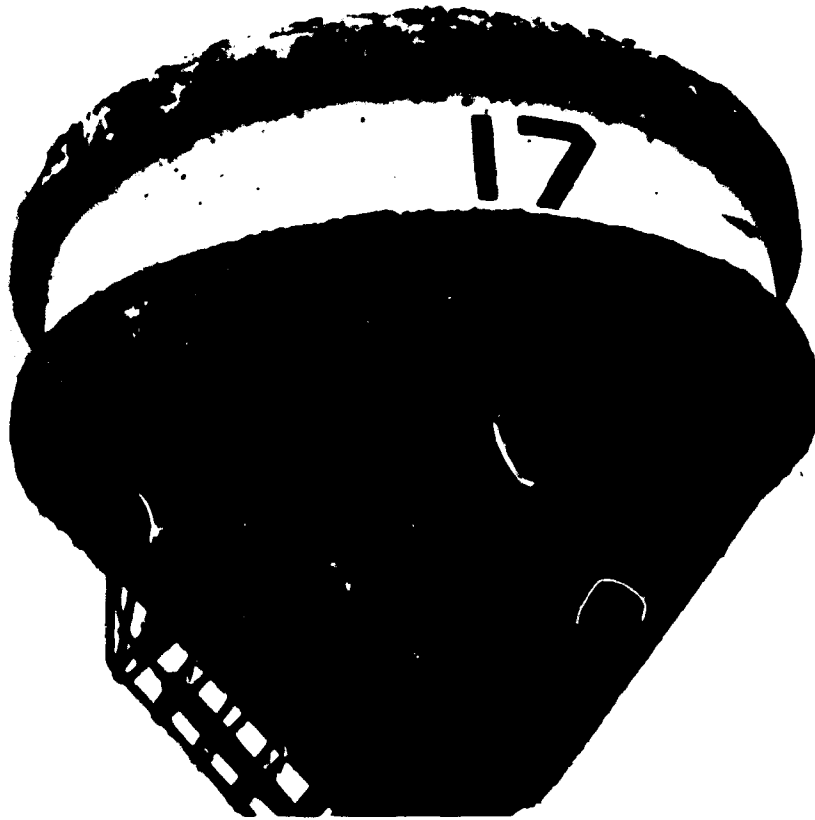
The condition of the System 7C buoy (Figure 9) had not changed appreciably since the last inspection. The medium amount of blistering noted in the submerged zone at the time of the last inspection had not increased appreciably. The gradual erosion of the antifouling coating continued to expose the underlying primer. Additional amounts of the antifouling appeared to be lost during the high-pressure hosing of the fouling organisms. The amount and type of fouling were similar to those on test buoys without antifouling paint. Pinpoint rusting occurred in the tidal zone.

Figure 9. System 7C buoy after removal of fouling.

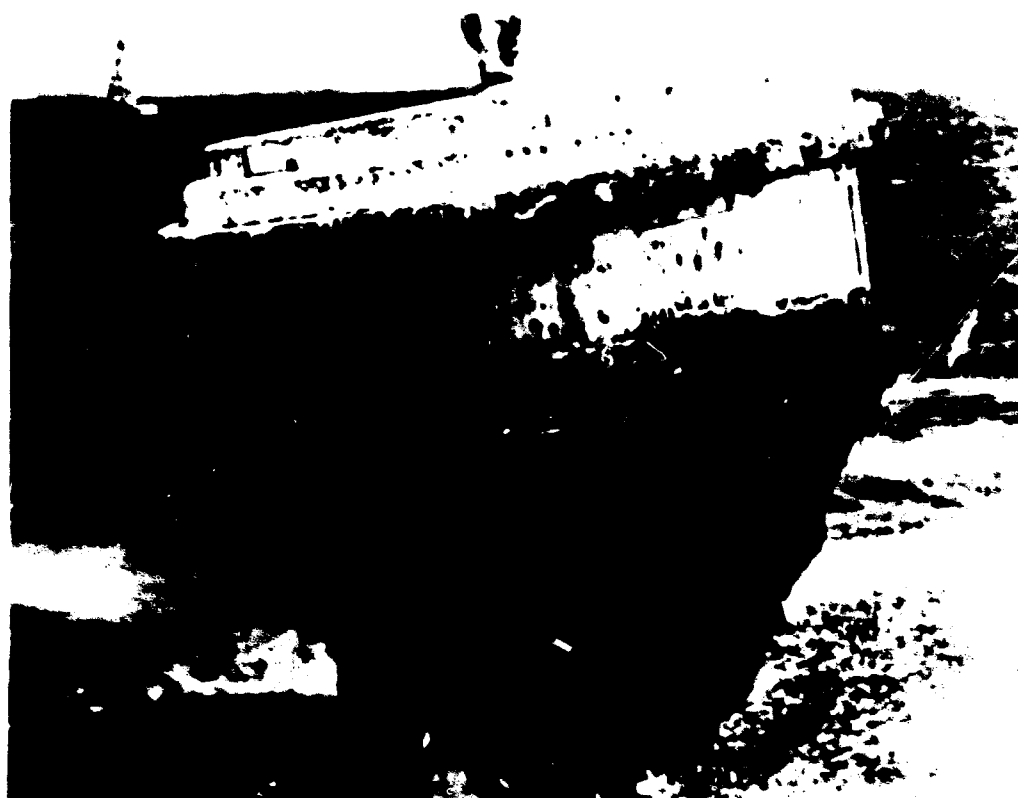
Figure 14. System 10 buoy during removal of fouling.

The System 10 buoy continued to show increased blistering of coating, and rusting of exposed steel (Figure 14). Many of the blisters were unbroken and contained yellow water. The steel beneath the unbroken blisters was rust-free. Yellow water had previously been found⁹ inside blisters of the same proprietary coating on the interior of a potable-water storage tank. Analysis of both this liquid and of the original primer used on the tank interior showed that chromium was present, even though this was denied by the coating supplier. It appears that osmotic pressure created by the presence of soluble chromium salts may have resulted in blistering both on the buoy and the tank interior.

Because of the advanced deterioration on the splash and submerged zones of the System 10 buoy, it will probably be removed from service in the near future.

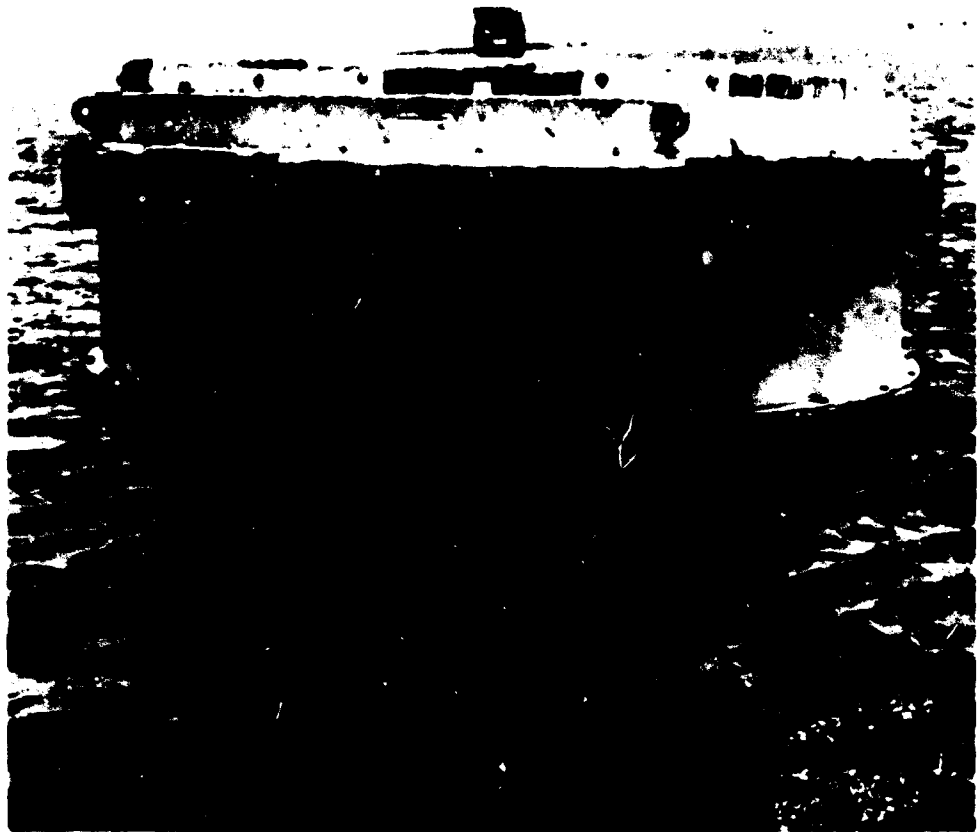
The condition of the System 12 buoy (Figure 15) had deteriorated only slightly since the last inspection. The slight rusting on the top and side was related to abrasion damage. Although about half of the primer and topcoat had been lost from the submerged zone during the first 6 months, the underlying inorganic zinc silicate has been effective in mitigating corrosion. The slight amount of pinpoint corrosion in this area may be due to a gradual loss of zinc in protecting the steel.

Figure 15. System 12 buoy before removal of fouling.

The inorganic zinc silicate of System 12 seems to be losing its effectiveness in retarding corrosion because slight rusting was noted for the first time in areas where the topcoating had previously been lost.
